John Ruskin Primary School and Language Classes

Asbestos Management Plan

Date approved: 2024

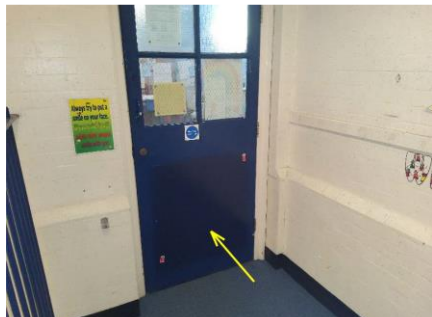
Insulation board panels to inside of Entrance Door (Behind Timber Panels) x1	Good / Low Medium / High

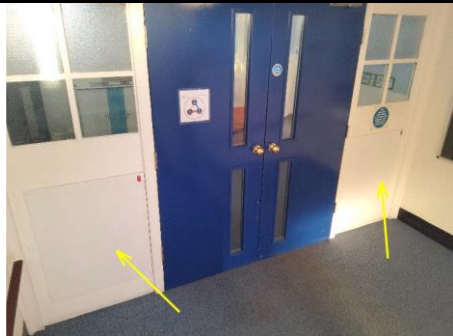
Insulation board panels to Sides of Double Doors x 2	Good / Low Medium / High	
2nd Floor – 3 Cloakroom opposite Azure Class

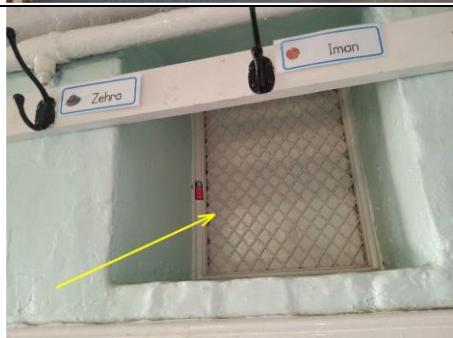
Insulation board panels within Alcove Behind Wire Mesh	Good / Low Medium / High	
2nd Floor – 4 Stairwell/next to Azure Class

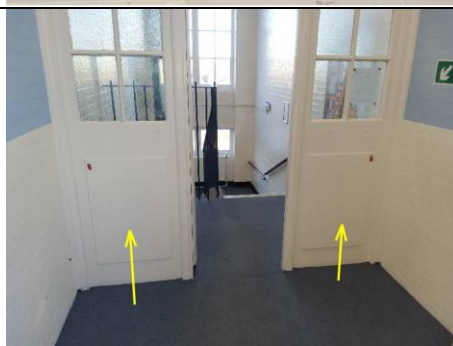
Insulation board panels either side of doors x 2	Good / Low Medium / High

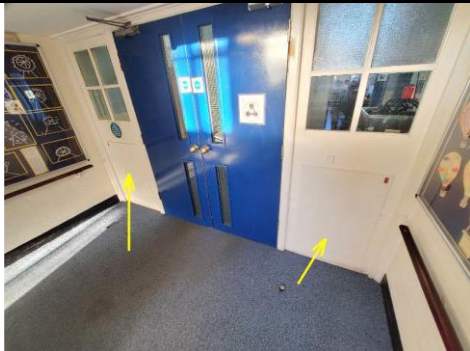
Insulation board panels to Sides of Double Doors x 2	Good / Low Medium / High	
2 nd Floor – 6 Cloakroom/Opposite Vermilion Class

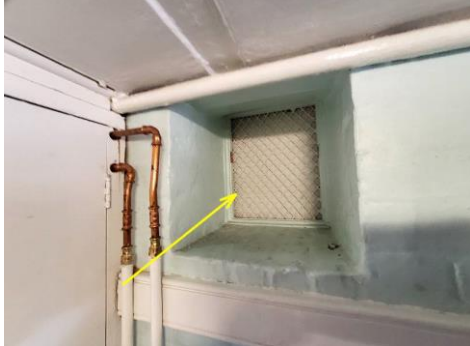
Insulation board Behind Wire Mesh	Good / Low Medium / High	
2 nd Floor – 7 Stairwell/next to Violet Class

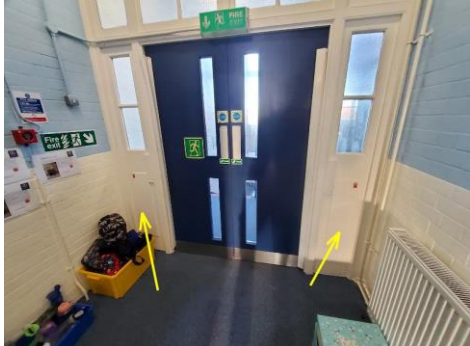
Insulation board panels behind fixed timber panels to Sides of Double Doors x 2	Good / Low Medium / High

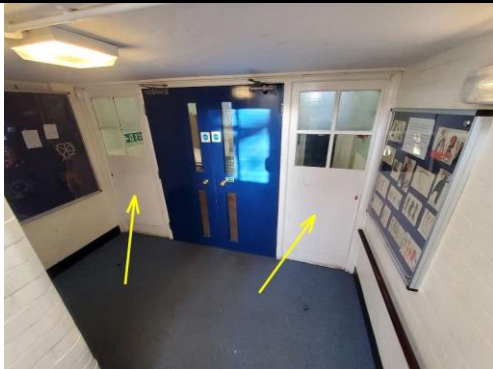
Insulation board panels to Sides of Double Doors x 2	Good / Low Medium / High	
1 st Floor – 9 Boys toilets

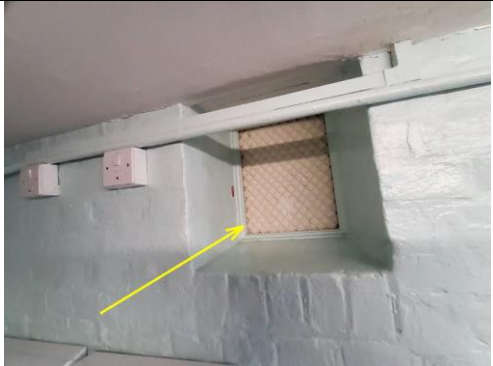
Insulation board panels behind Behind Wire Mesh x1	Good / Low Medium / High	
1 st Floor – 10 Stairwell/next to Staff Room

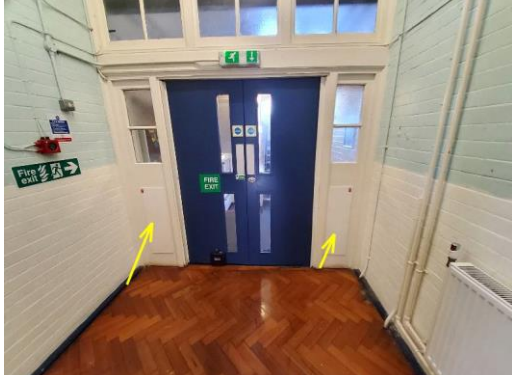
Insulation board panels to sides of double doors x 2	Good / Low Medium / High

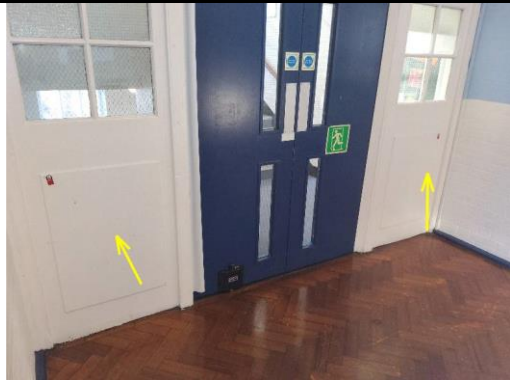
Insulation board panels beside double doors x 1	Good / Low Medium / High	
1 st Floor – 12 Stairwell/opposite Green Class

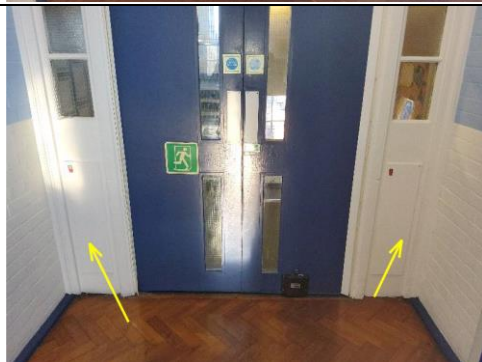
Insulation board panels besides double doors x 2	Good / Low Medium / High	
1 st Floor – 13 Stairwell/next to Green Class

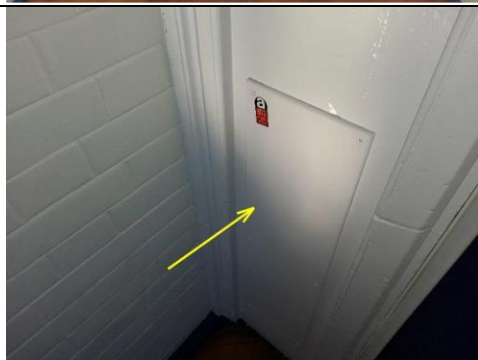
Insulation board panels beside doors x 2	Good / Low Medium / High

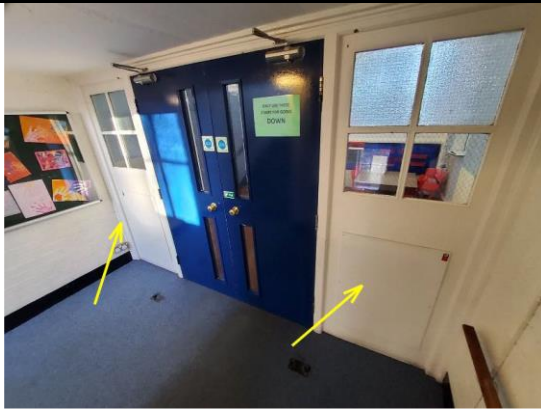
Insulation board panel beside double doors x 2	Good / Low Medium / High	
Ground Floor – 15 Cellar opposite Yellow Class

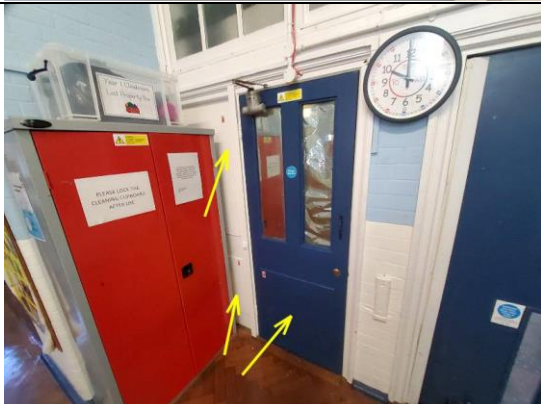
Insulation board panel to Cellar Door & Side Panels x3	Good / Low Medium / High

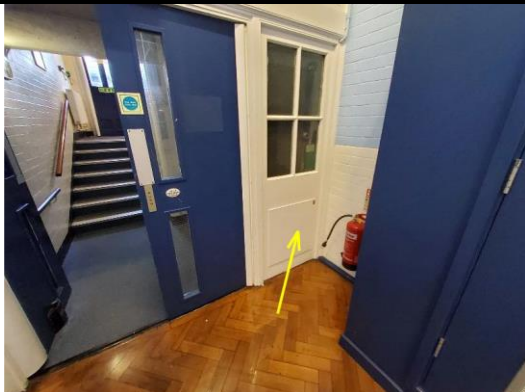
Insulation board panels to side of door x 1	Good / Low Medium / High	
Ground Floor – 17 Inside cellar opposite Yellow

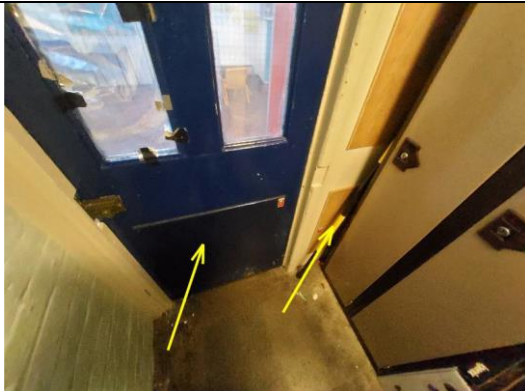
Insulation board panels to Door and side panels x 3	Good / Low Medium / High

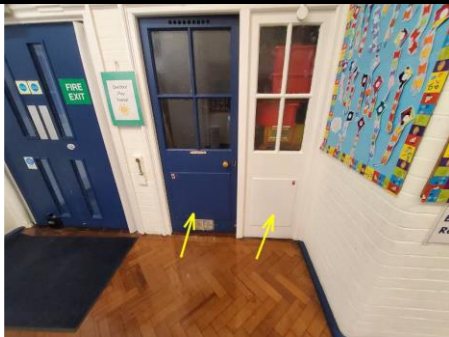
Insulation board panels to door and beside door x 2	Good / Low Medium / High	
Ground Floor – 19 Maths cupboard

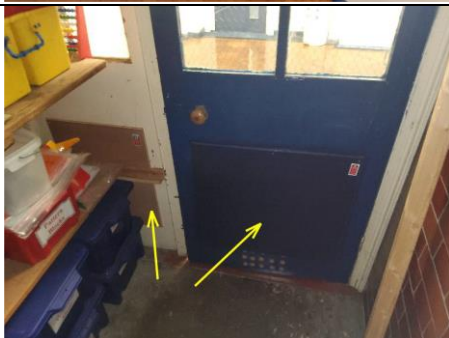
Insulation board panels to door and beside door x 2	Good / Low Medium / High	
Ground Floor Mezz – 20 Asst. SENCO/DHT Rooms

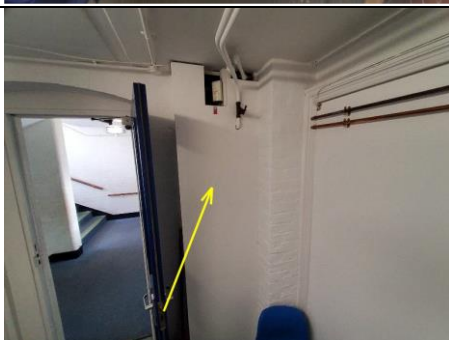
Insulation board panels behind Timber Boxing x1	Good / Low Medium / High

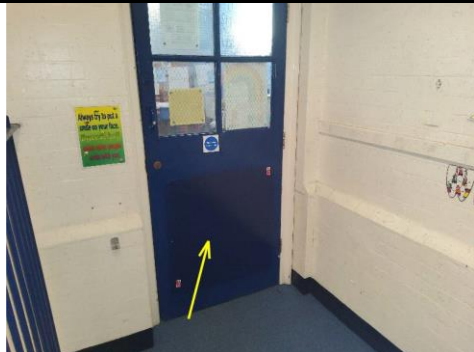
Insulation board panel to 2nd & 3rd Floor outside of class Entrance Door x1	Good / Low Medium / High	
Second Floor – 22 Stairwell/Opposite Azure Class

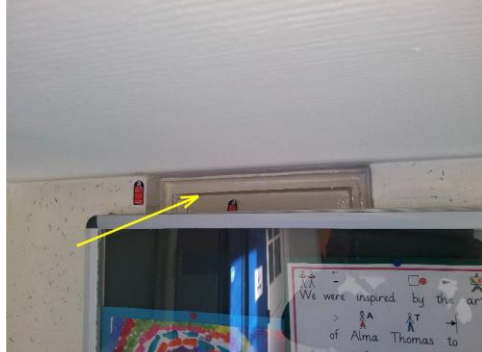
Insulation board panel behind noticeboard x 1	Good / Low Medium / High	
2 nd Floor – 23 Stairwell/opposite Azure Class

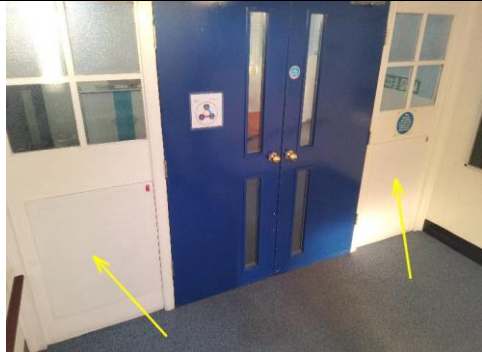
Insulation board panel either side of double doors x 2	Good / Low Medium / High

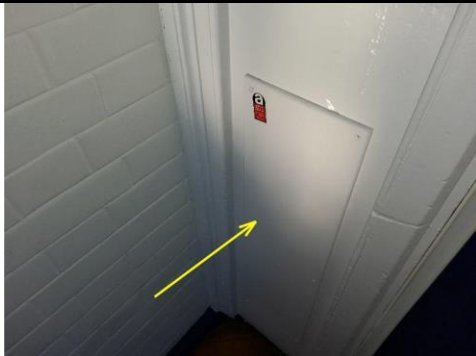
Insulation board beside double doors behind timber panels x 1	Good / Low Medium / High	
Second Floor – 25 Stairwell/opposite Vermilion class

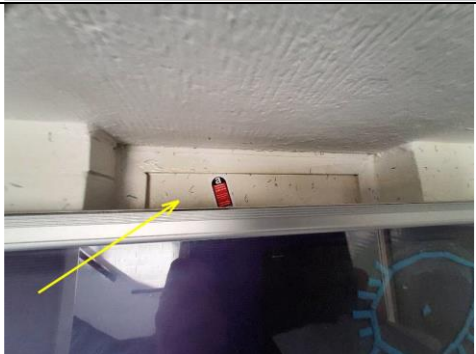
Insulation board behind noticeboard x 1	Good / Low Medium / High	
Ground Floor Mezz – 26 Stairs/Near HT office door

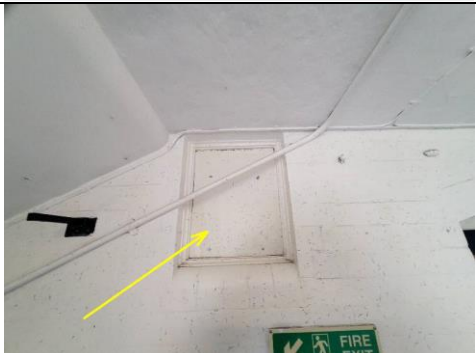
Insulation board panels behind alcove x1	Good / Low Medium / High

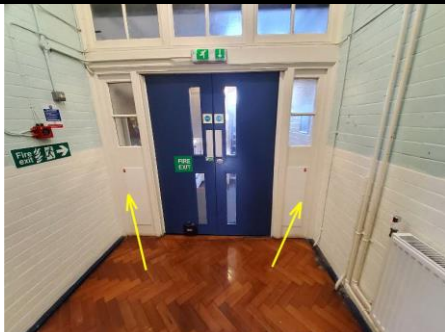
Insulation boards beside doors x 2	Good / Low Medium / High	
Second Floor – 28 Stairwell/ Opposite Library

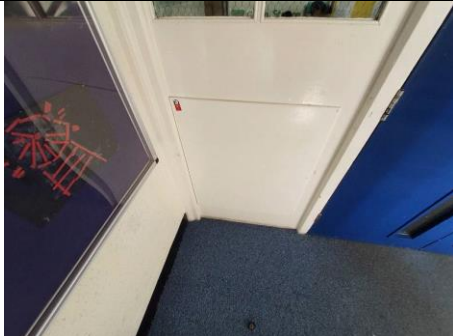
Insulation boards beside doors x 2	Good / Low Medium / High	
Second Floor – 29 Stairwell/ next to Violet Class

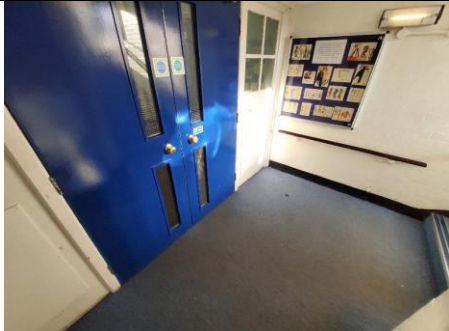
Insulation boards beside doors x 2	Good / Low Medium / High

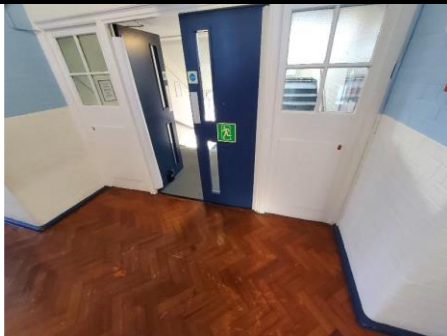
Insulation boards beside doors x 2	Good / Low Medium / High	
Second Floor – 31 Stairwell/cleaner's cupboard understairs of Yellow Stairs

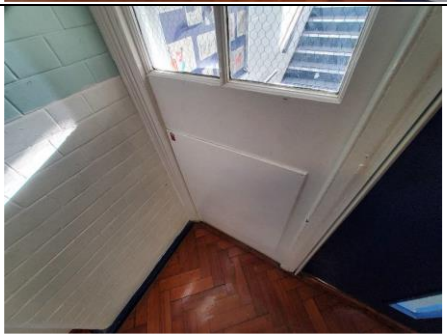
Insulation boards beside doors x 1	Good / Low Medium / High	
Second Floor – 32 Stairwell/next to Azure class

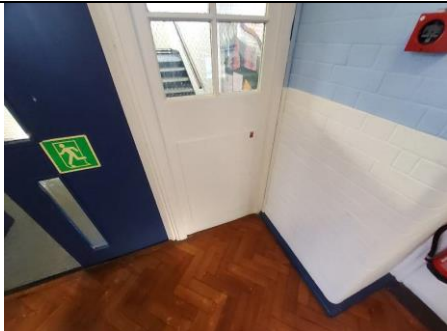
Insulation boards beside doors x 2	Good / Low Medium / High

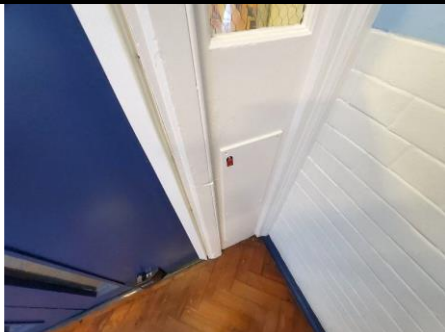
Insulation boards beside doors x 1	Good / Low Medium / High	
External – Middle Playground – 34 Skylight in shed area

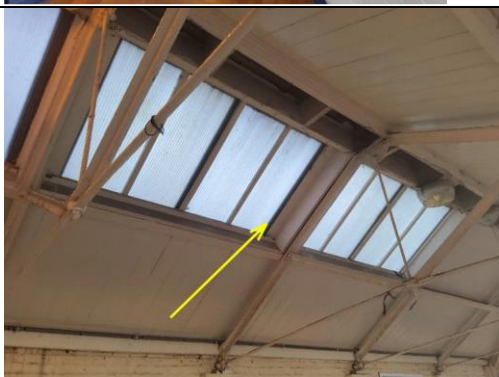
Rope Seal 20m	Good / Low Medium / High	
Basement – 35 Entrance to boiler room on wall

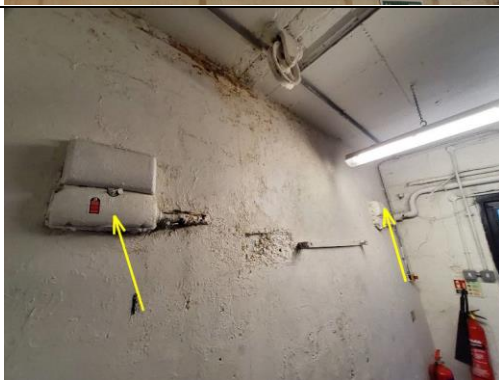
Rope flashguards within electrical switchgear boxes x2	Good / Low Medium / High

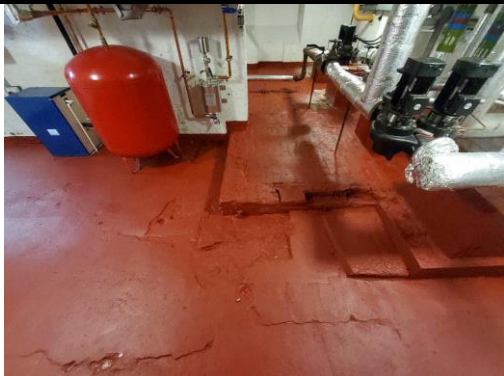
Thermal Insulation Residue to floor and plinths 16m	Good / Low Medium / High	
Basement – 37 Pump room

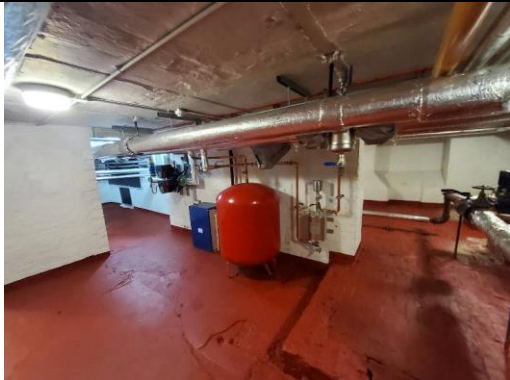
Thermal Insulation Residue to all walls 40m	Good / Low Medium / High

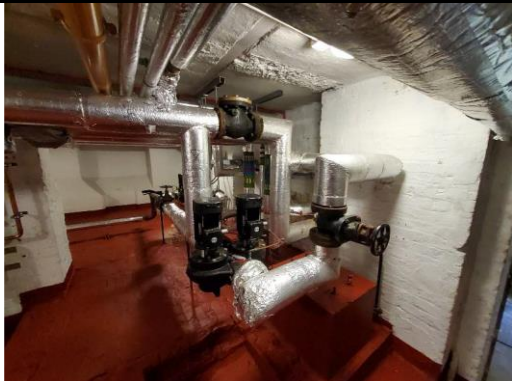
Thermal Insulation Residue to all walls 20m	Good / Low Medium / High	
Basement – 39 Pump room

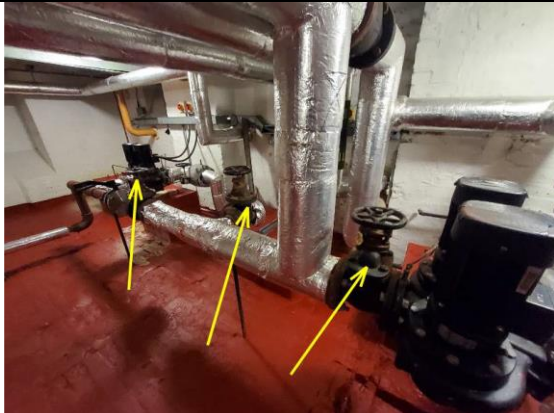
Gaskets within pipework flanges	Good / Low Medium / High

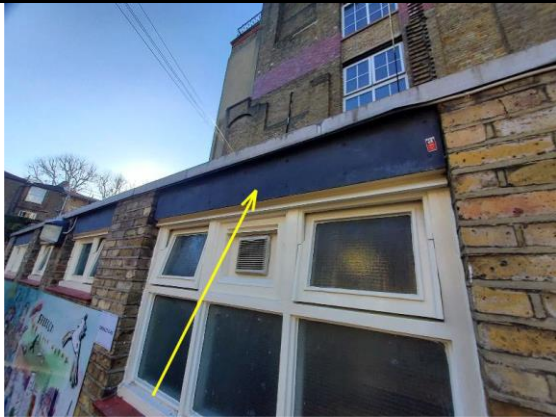
Cement panels - toilet block above windows x5	Good / Low Medium / High	
Basement – 41 1 st store room

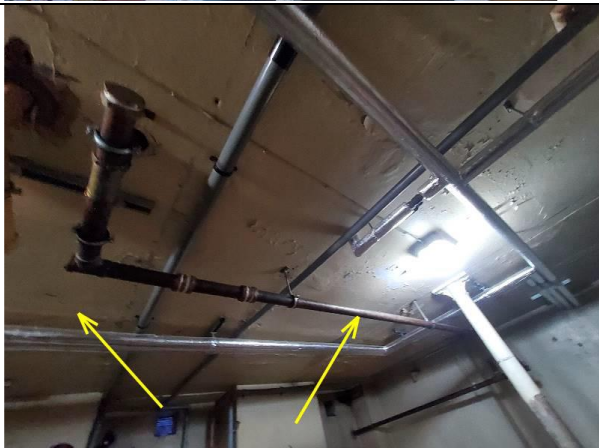
Thermal insulation residue to concrete ceiling 20m Area sealed off until encapsulation works are carried out	Good / Low Medium / High

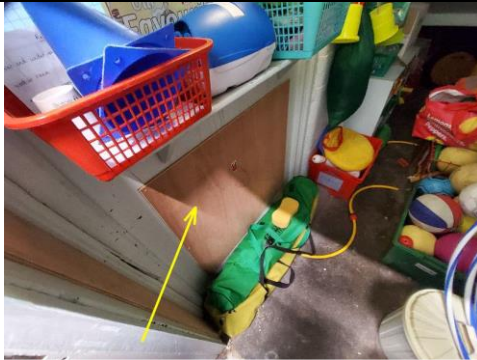
Insulation board panel each side of wall behind timber x 2	Good / Low Medium / High	
Ground Floor – LU – 3 Hall exit to JRN playground

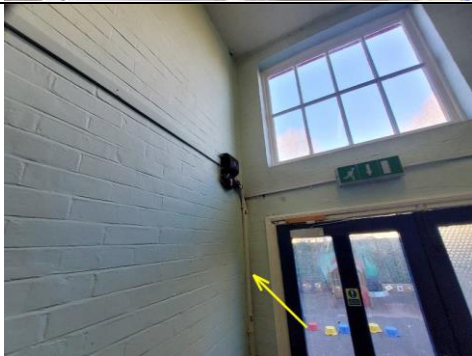
Bitumen wrap to mains cable 3m	Good / Low Medium / High	
Ground Floor – LU – 4 Hall exit to JRN playground

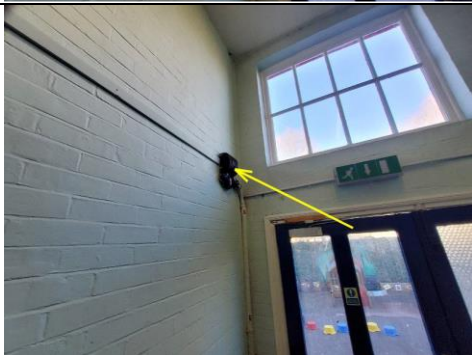
Rope flashguards within electrical switchgear box	Good / Low Medium / High

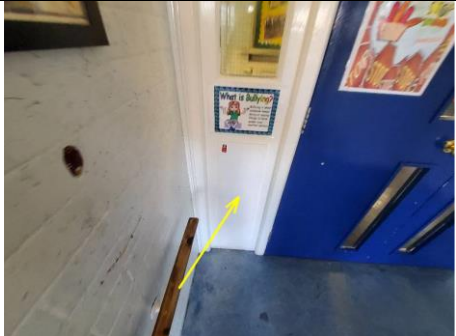
Insulation board panel to doors x 1	Good / Low Medium / High	
First Floor – LU – 6 First floor entrance

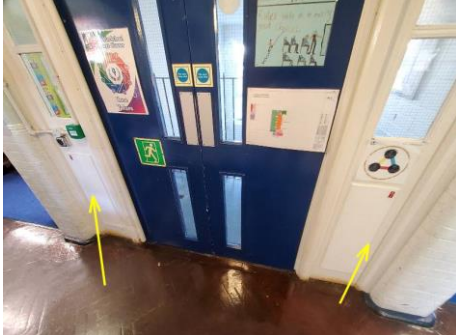
Insulation board panel to doors inside hall x 2	Good / Low Medium / High	
First Floor – LU – 7 First floor entrance

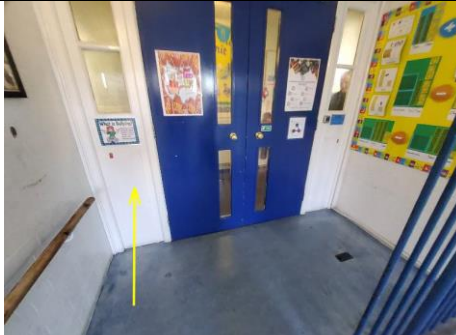
Insulation board panel to doors outside hall x 2	Good / Low Medium / High

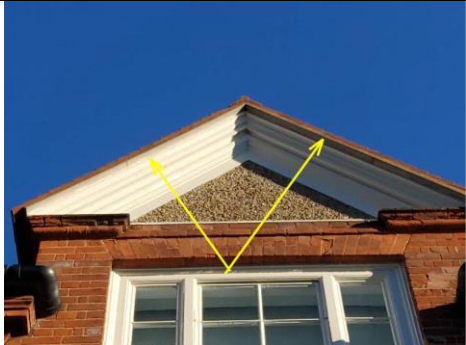
Cement undercloaking to gable ends of pitched roof areas	Good / Low Medium / High
